Manhole Inspection Summary

Manhole # S29G__012MH

Insp Date: **5/12/09 11:01 AM**

Location Address: **10 S ARCH ST**

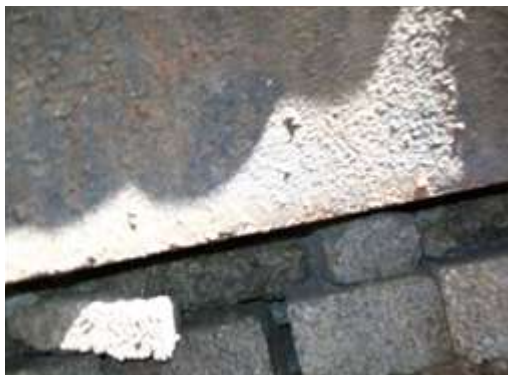
Defect 2

Condition: ☐ Sound ☐ Cracked ☐ Root Intrusion ☒ **Loose Brick** ☐ Deteriorated

LOOSE CHIMNEY CYNDER BRICK

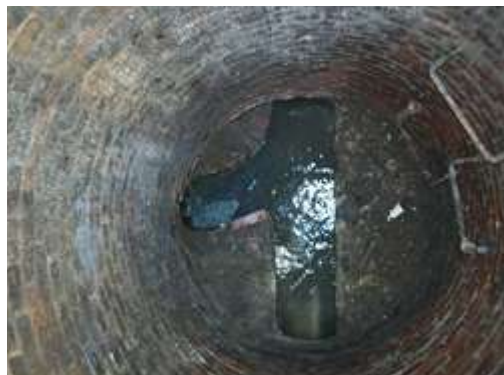
Defect 1

Count: **8** Missing: **0** ☒ **Corroded**

Steps Corroded

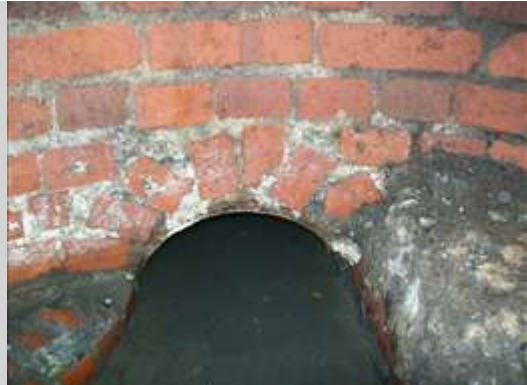
12 O'Clock Outflow

12 in. Circular Gravity Sewer
Pipe Out @ 12 O'Clock

Pipe Height: **12** (in.) Rod and Bar (Angled)
Pipe Material: **Clay** ☐ Pipe Lined
Invert Depth: **12.42** (ft.) Flow Characteristics: **Slow**
Deposits: ☒ None ☐ Mud ☐ Sludge ☐ Debris ☐ Grease
Silt Depth: **0** (in.) Deposits Extent:
Infiltration: **None** Pipe Seal Cond: **Sound**

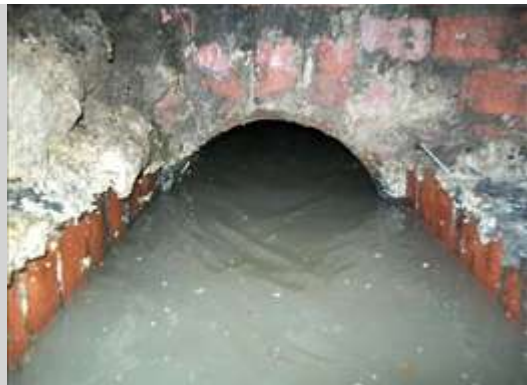
6 O'Clock Inflow

12 in. Circular Gravity Sewer
Pipe In @ 6 O'Clock

Pipe Height: **12** (in.) Rod and Bar (Angled)
Pipe Material: **Clay** ☐ Pipe Lined
Invert Depth: **12.28** (ft.) Flow Characteristics: **Slow**
Deposits: ☒ None ☐ Mud ☐ Sludge ☐ Debris ☐ Grease
Silt Depth: **0** (in.) Deposits Extent:
Infiltration: **None** Pipe Seal Cond: **Sound**

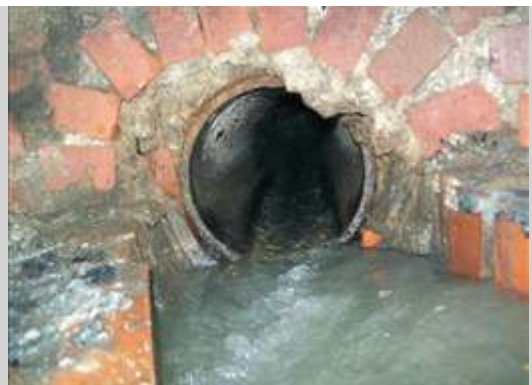
9 O'Clock Inflow

8 in. Circular Gravity Sewer
Pipe In @ 9 O'Clock

Pipe Height: **8.4** (in.) Rod and Bar (Angled)

Pipe Material: **Clay** ☐ Pipe Lined

Pipe Seal Cond: **Sound**
